Infrared Thermal Imaging Survey Report

Customer: XXXXXXXX XXXXXXXX

Site Address: 27 XXXXXXXX Street, XXXXX

Inspected by: Bob Pike (Certified Thermographer)

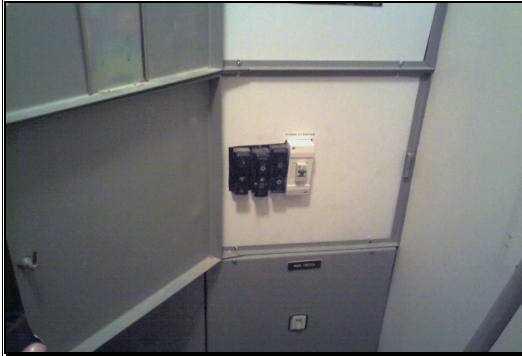
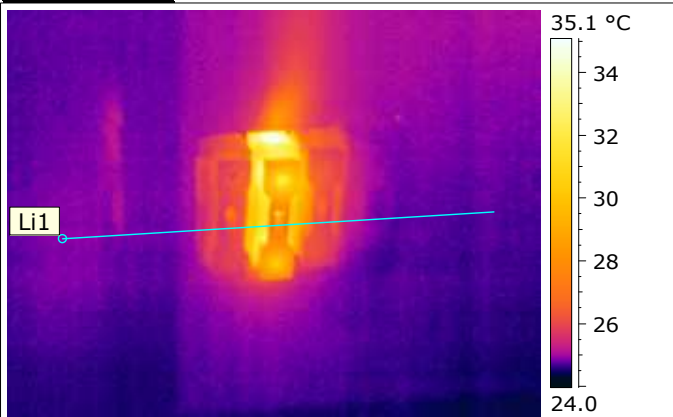
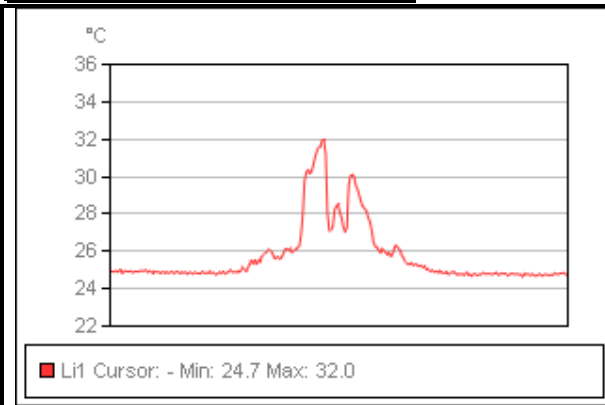
Location	XXXXXXX
Equipment	Sub Board 1

With this fuse showing at 7 degrees above ambient and 6 degrees higher than the two adjacent fuses, we would recommend that this be checked by a qualified electrician with a view to possibly balancing the loadings

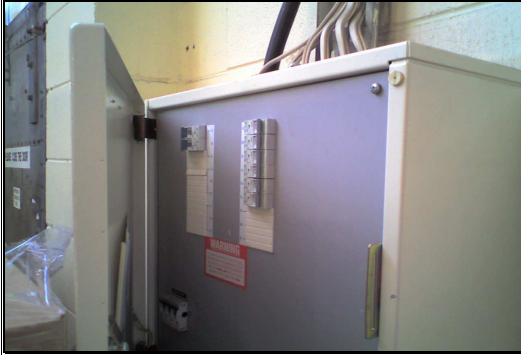
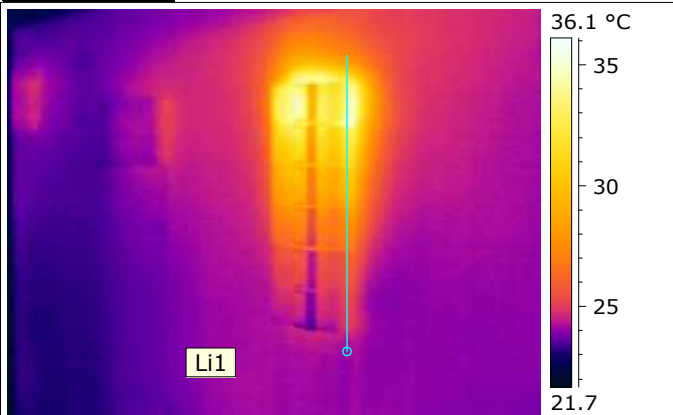
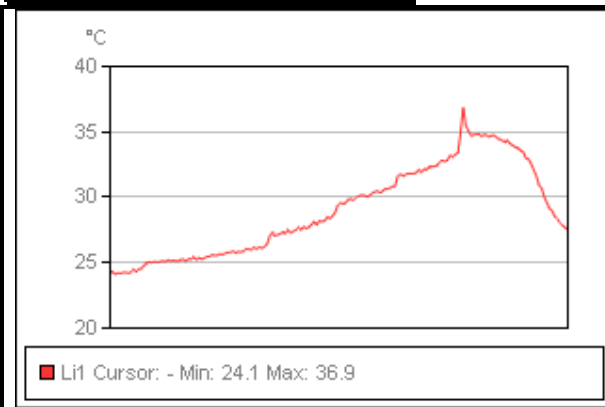
Location	XXXXXXX
Equipment	XXXX XXXX

With this fuse showing at 14 degrees above ambient and 7 degrees higher than the adjacent fuses, we would recommend that this be checked by a qualified electrician with a view to possibly balancing the loadings

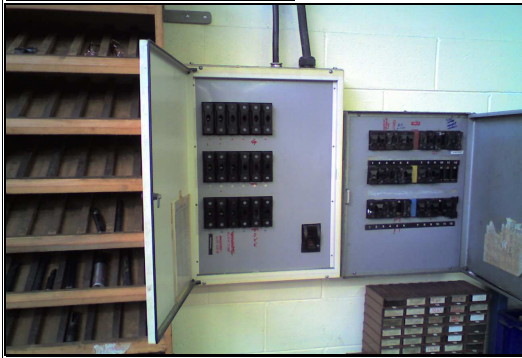
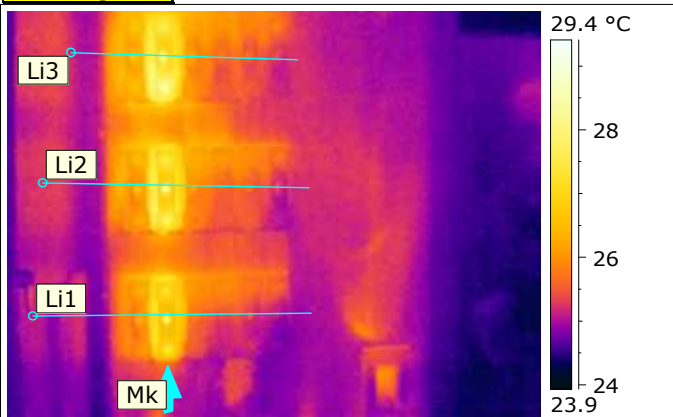
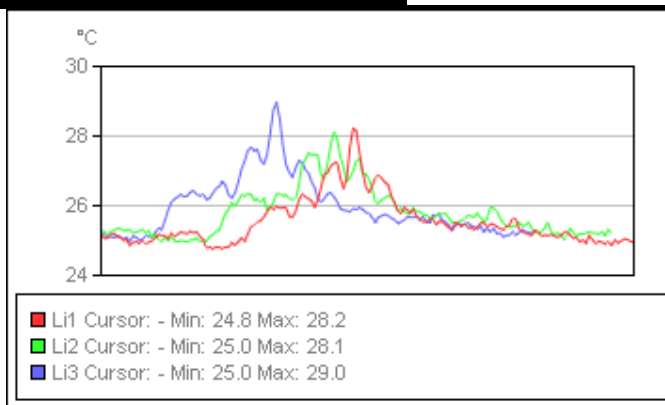
Location	Top Floor
Equipment	XXXX XXXX

All three phases on the circuit indicated are running at 4degrees higher than the other circuits. While not a huge variance, it would be worth having this checked to see if some loading could be transferred to another lesser loaded circuit.

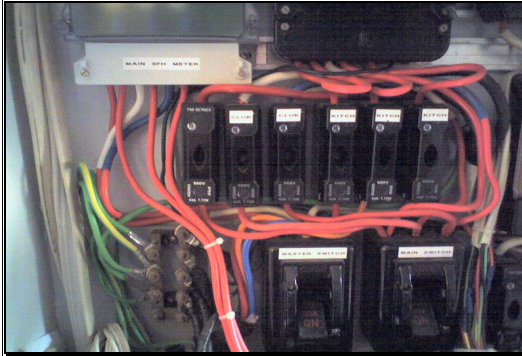
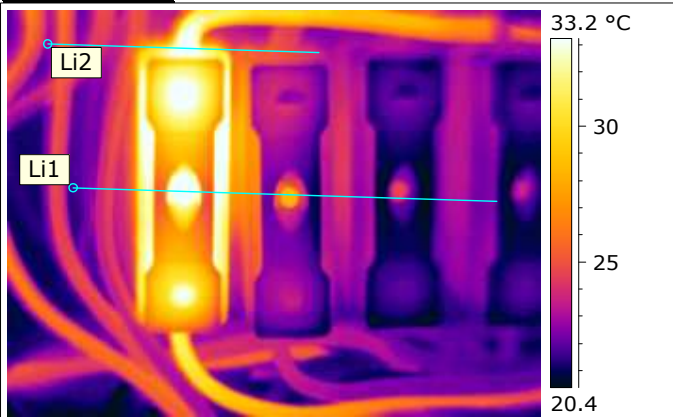
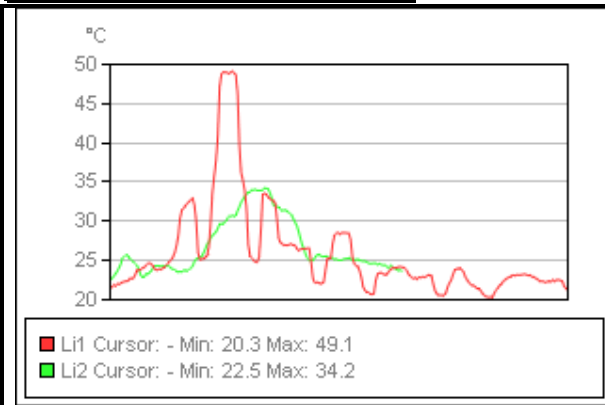
Location	Loading Dock
Equipment	XXXX XXXX

As these are the mains supply fuses, and the usage in the building is effectively all single phase, it would appear that this one phase is carrying a significant amount of the loading.
We would recommend that this be investigated by a qualified electrician with a view to balancing the loads

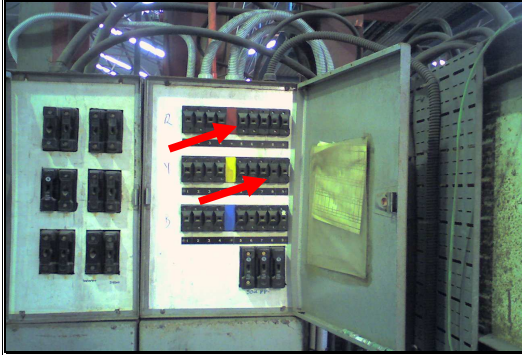
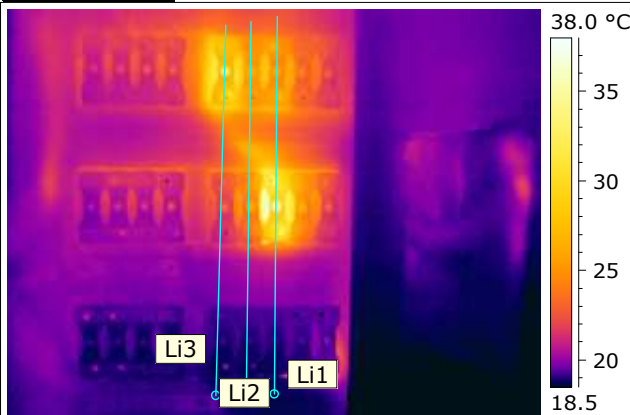
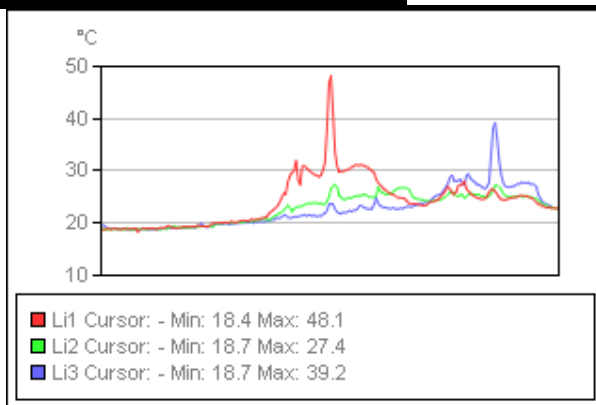
Location	Factory
Equipment	Sub board 2

With the yellow phase as indicated and running at almost 50degrees, this should be checked urgently by a qualified electrician and appropriate corrective action determined. There is also a fuse on the red phase (but different circuit) that is also showing elevated temperature but to a lesser extent but we still suggest this be also investigated.

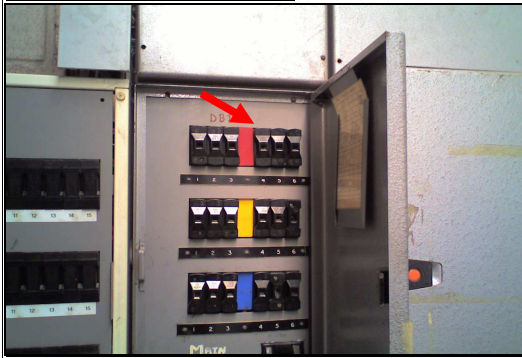
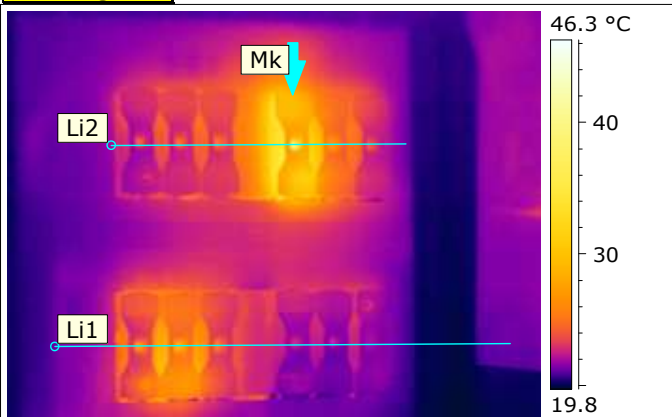
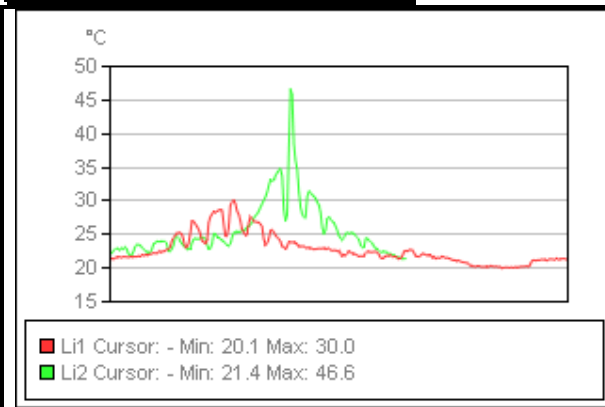
Location	XXXXXXXX
Equipment	Xxxx XXXX

With this fuse as indicated showing 47 degrees we recommend that this be investigated and rectified by a qualified electrician
